Lower Passaic River Restoration Project

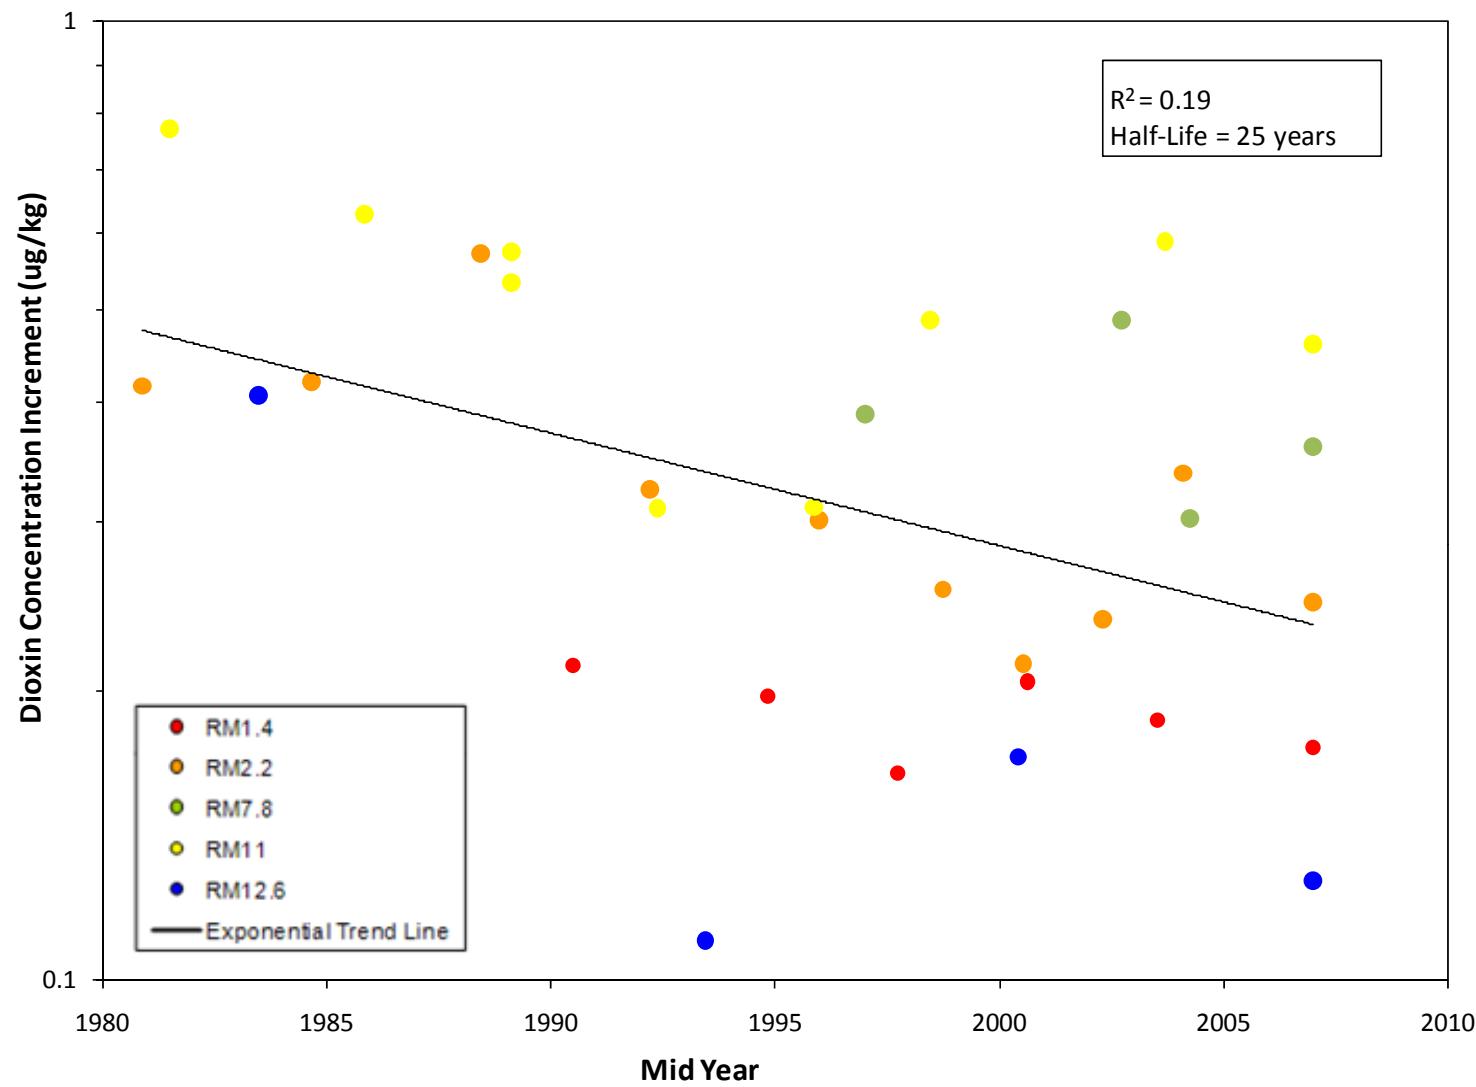
Figure 20-1

Concentration increment represents the difference between the measured concentration in the Lower Passaic River samples and the baseline concentration at Dundee Dam. The increment is attributed to resuspension and Newark Bay derived loads.

Dioxins Concentration Increment due to Resuspension and Newark Bay vs. Mid Year

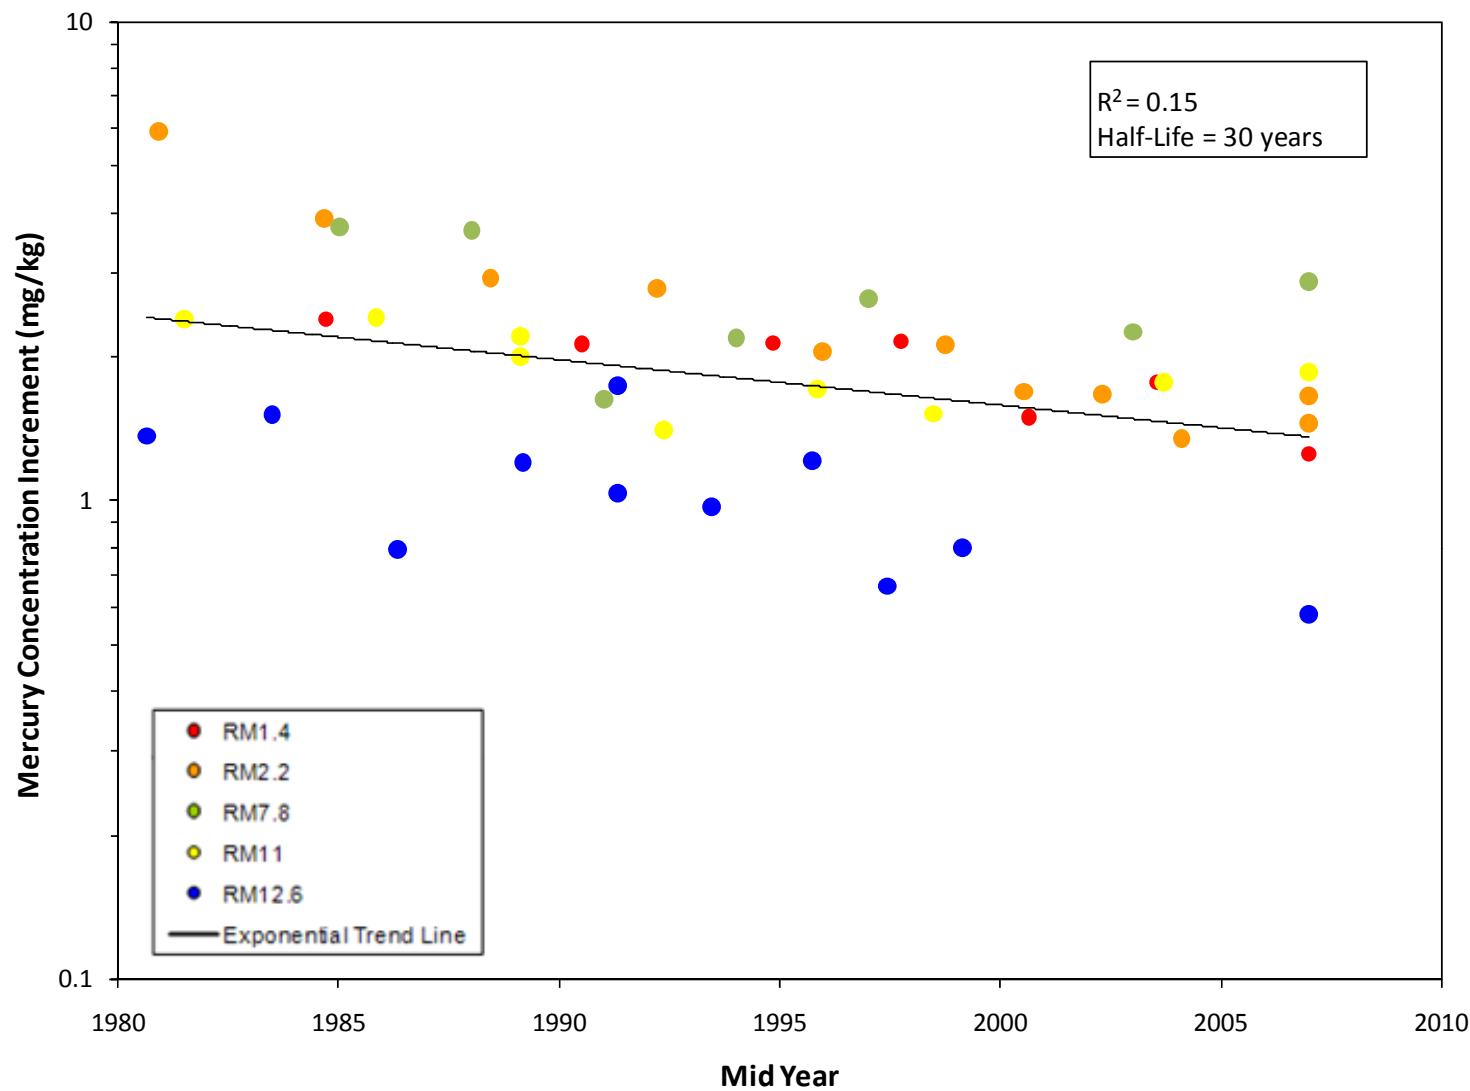
Figure 20-2

Concentration increment represents the difference between the measured concentration in the Lower Passaic River samples and the baseline concentration at Dundee Dam. The increment is attributed to resuspension and Newark Bay derived loads.

Mercury Concentration Increment due to Resuspension and Newark Bay vs. Mid Year

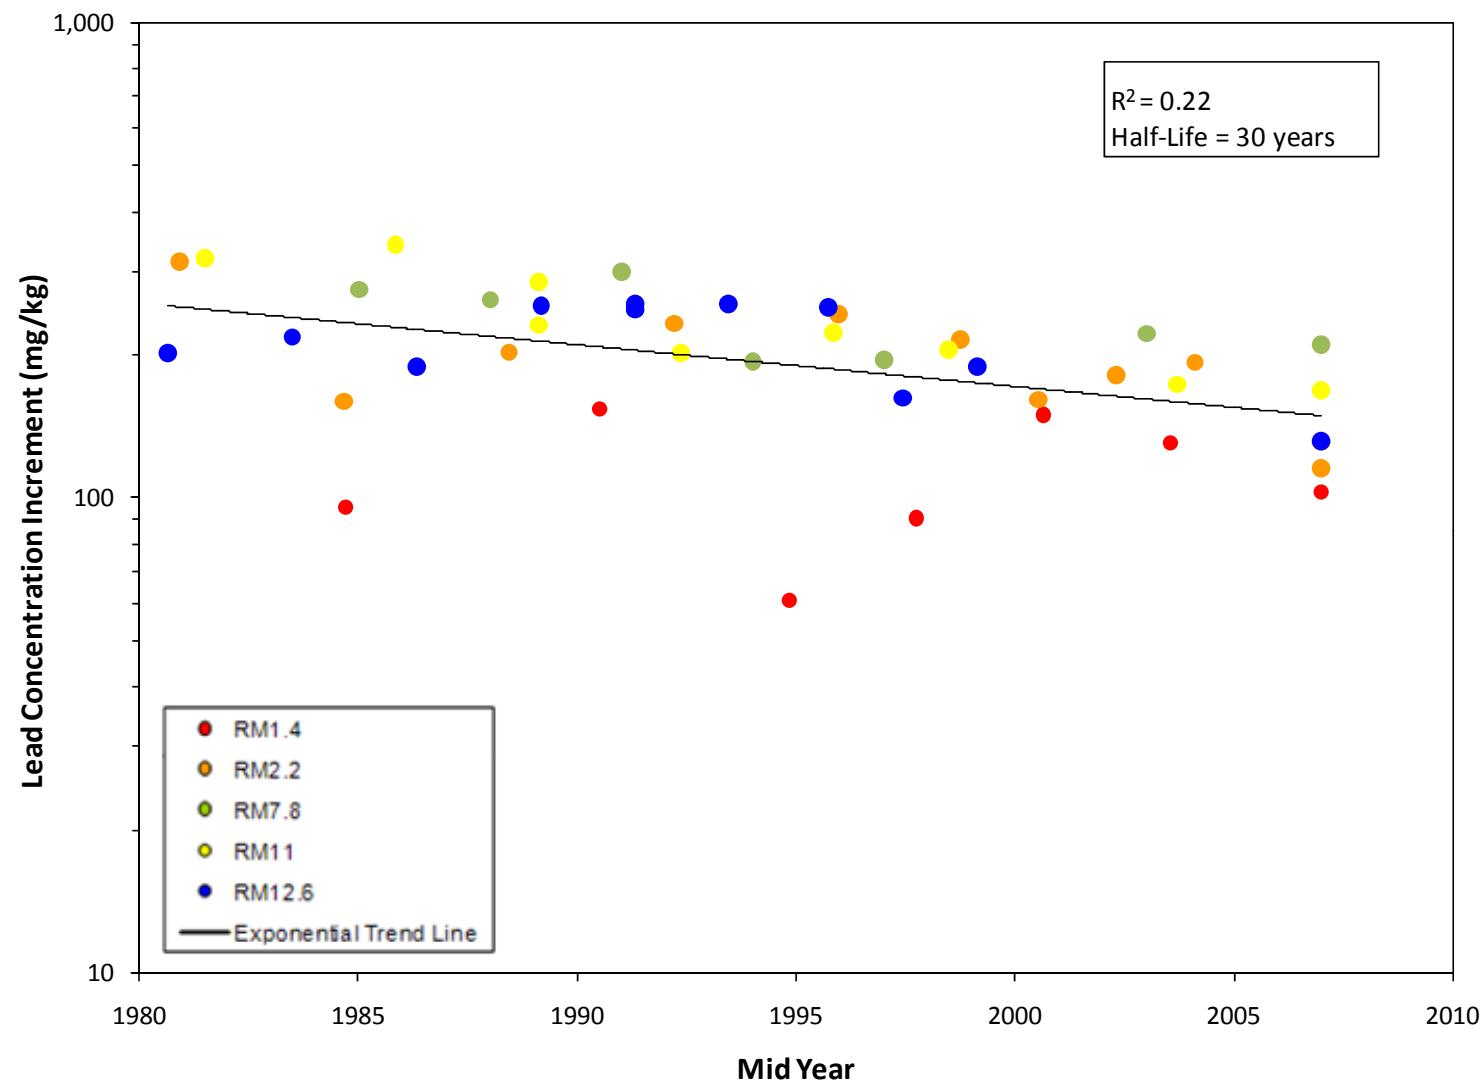
Figure 20-3

Concentration increment represents the difference between the measured concentration in the Lower Passaic River samples and the baseline concentration at Dundee Dam. The increment is attributed to resuspension and Newark Bay derived loads.

Lead Concentration Increment due to Resuspension and Newark Bay
vs. Mid Year
Lower Passaic River Restoration Project

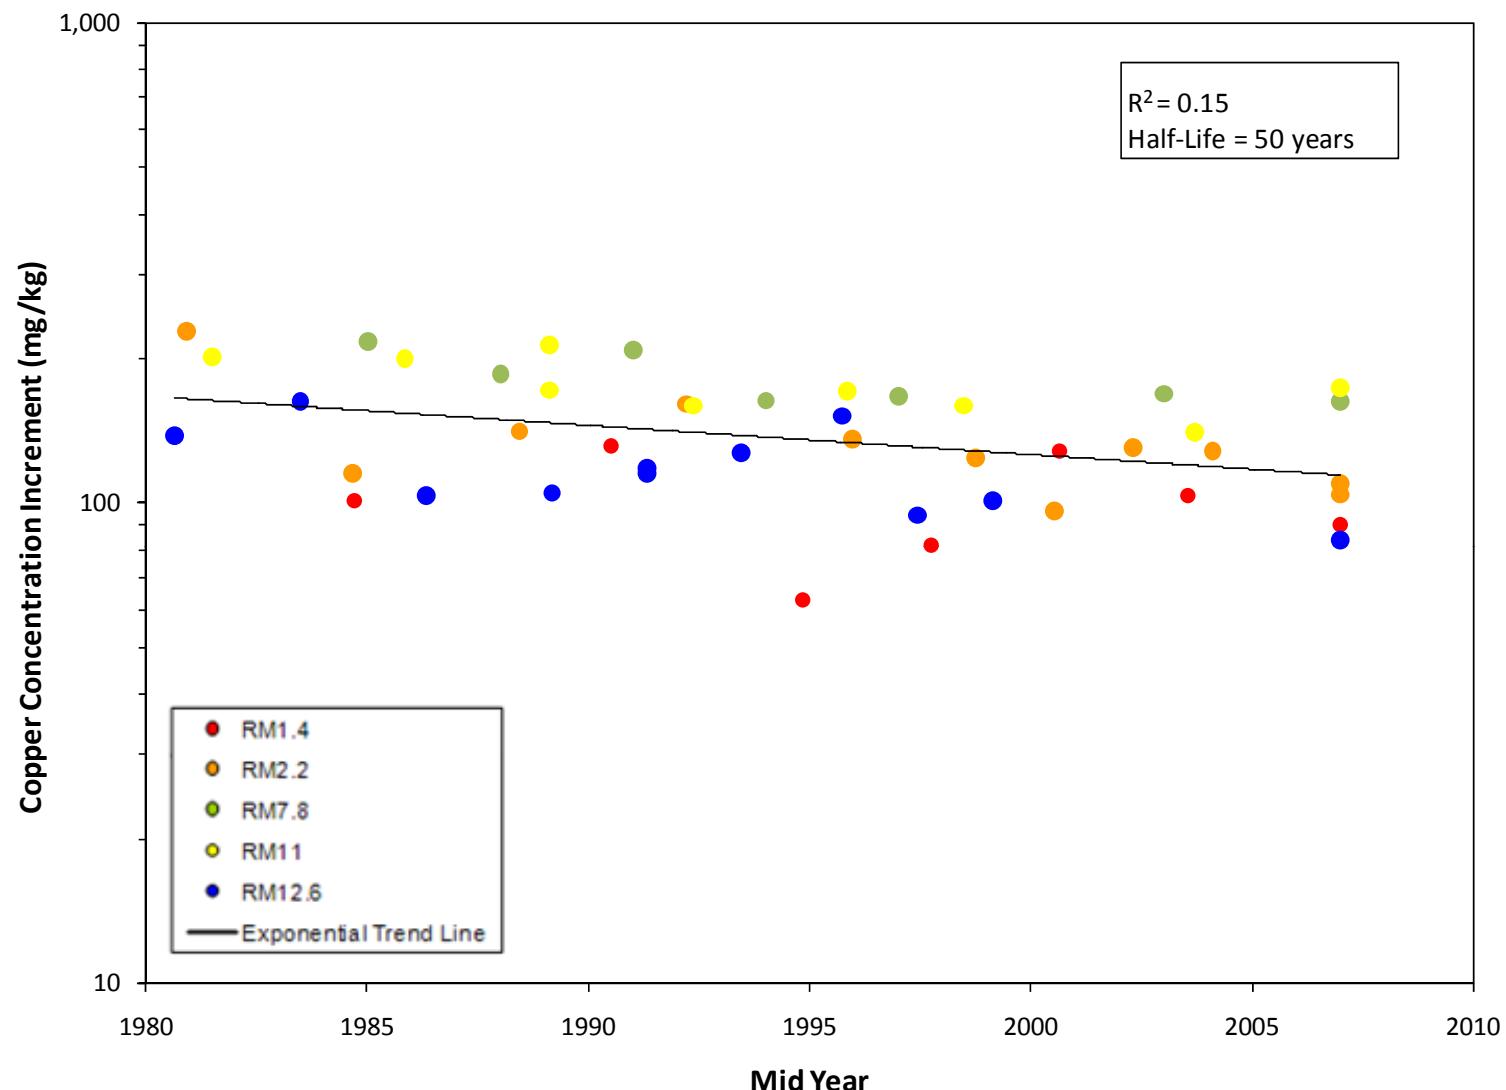
Figure 20-4

Concentration increment represents the difference between the measured concentration in the Lower Passaic River samples and the baseline concentration at Dundee Dam. The increment is attributed to resuspension and Newark Bay derived loads.

Copper Concentration Increment due to Resuspension and Newark Bay vs. Mid Year

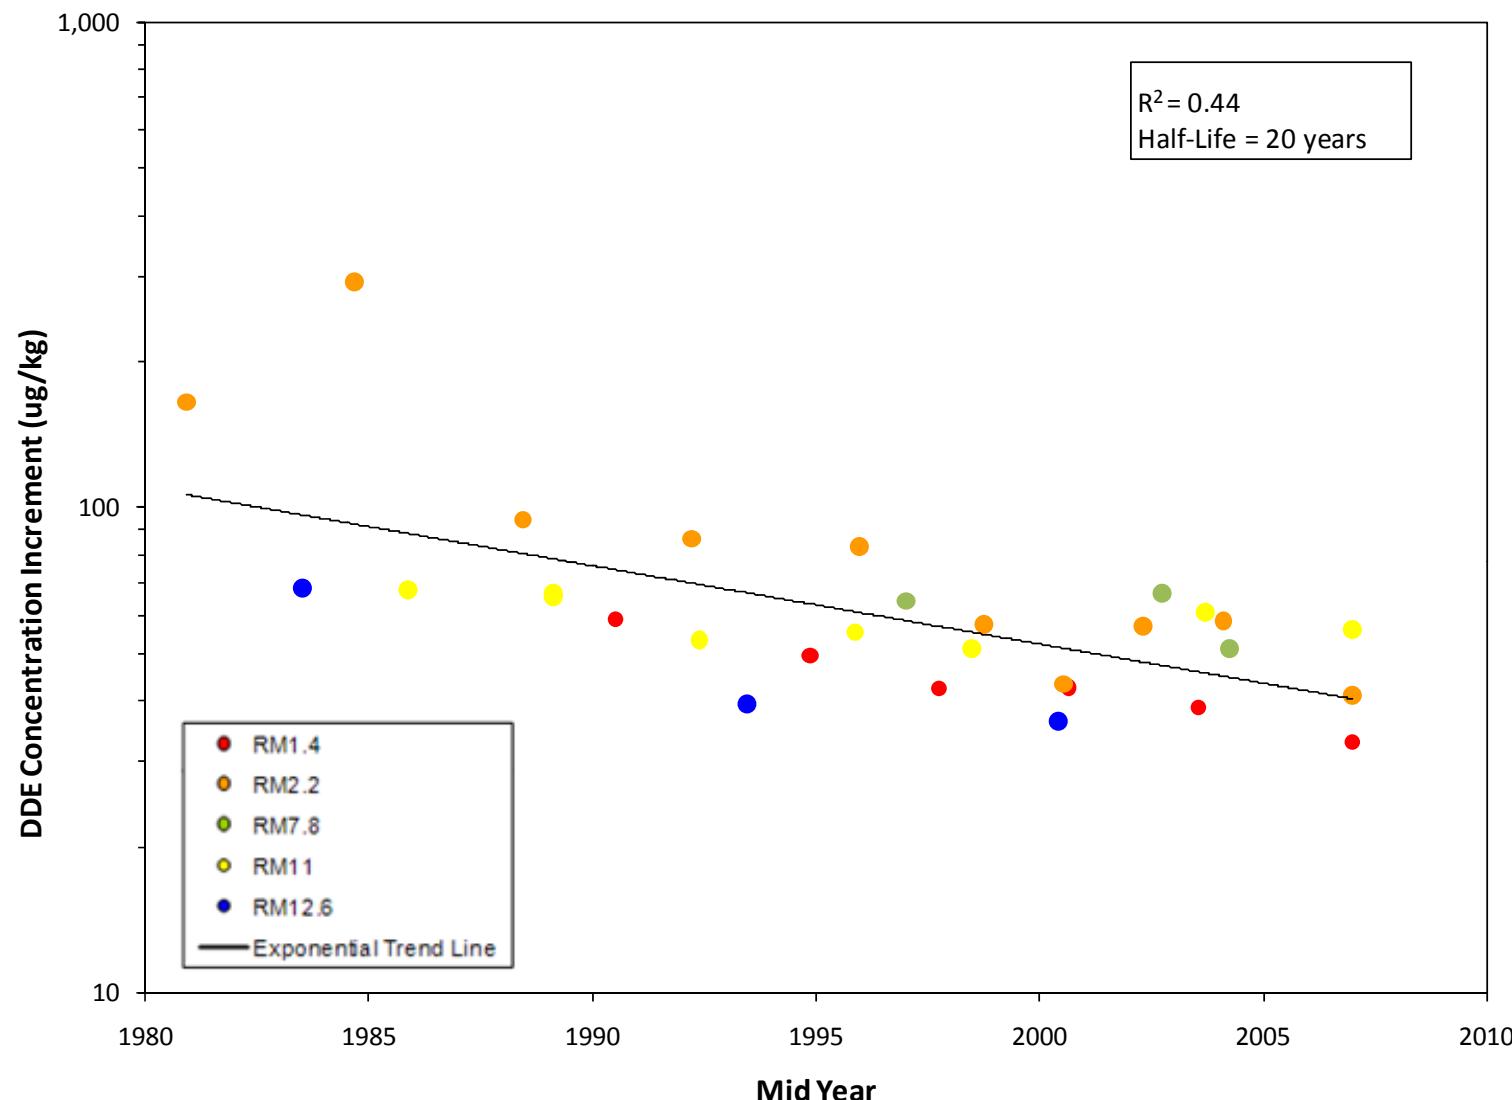
Figure 20-5

Concentration increment represents the difference between the measured concentration in the Lower Passaic River samples and the baseline concentration at Dundee Dam. The increment is attributed to resuspension and Newark Bay derived loads.

DDE Concentration Increment due to Resuspension and Newark Bay
vs. Mid Year

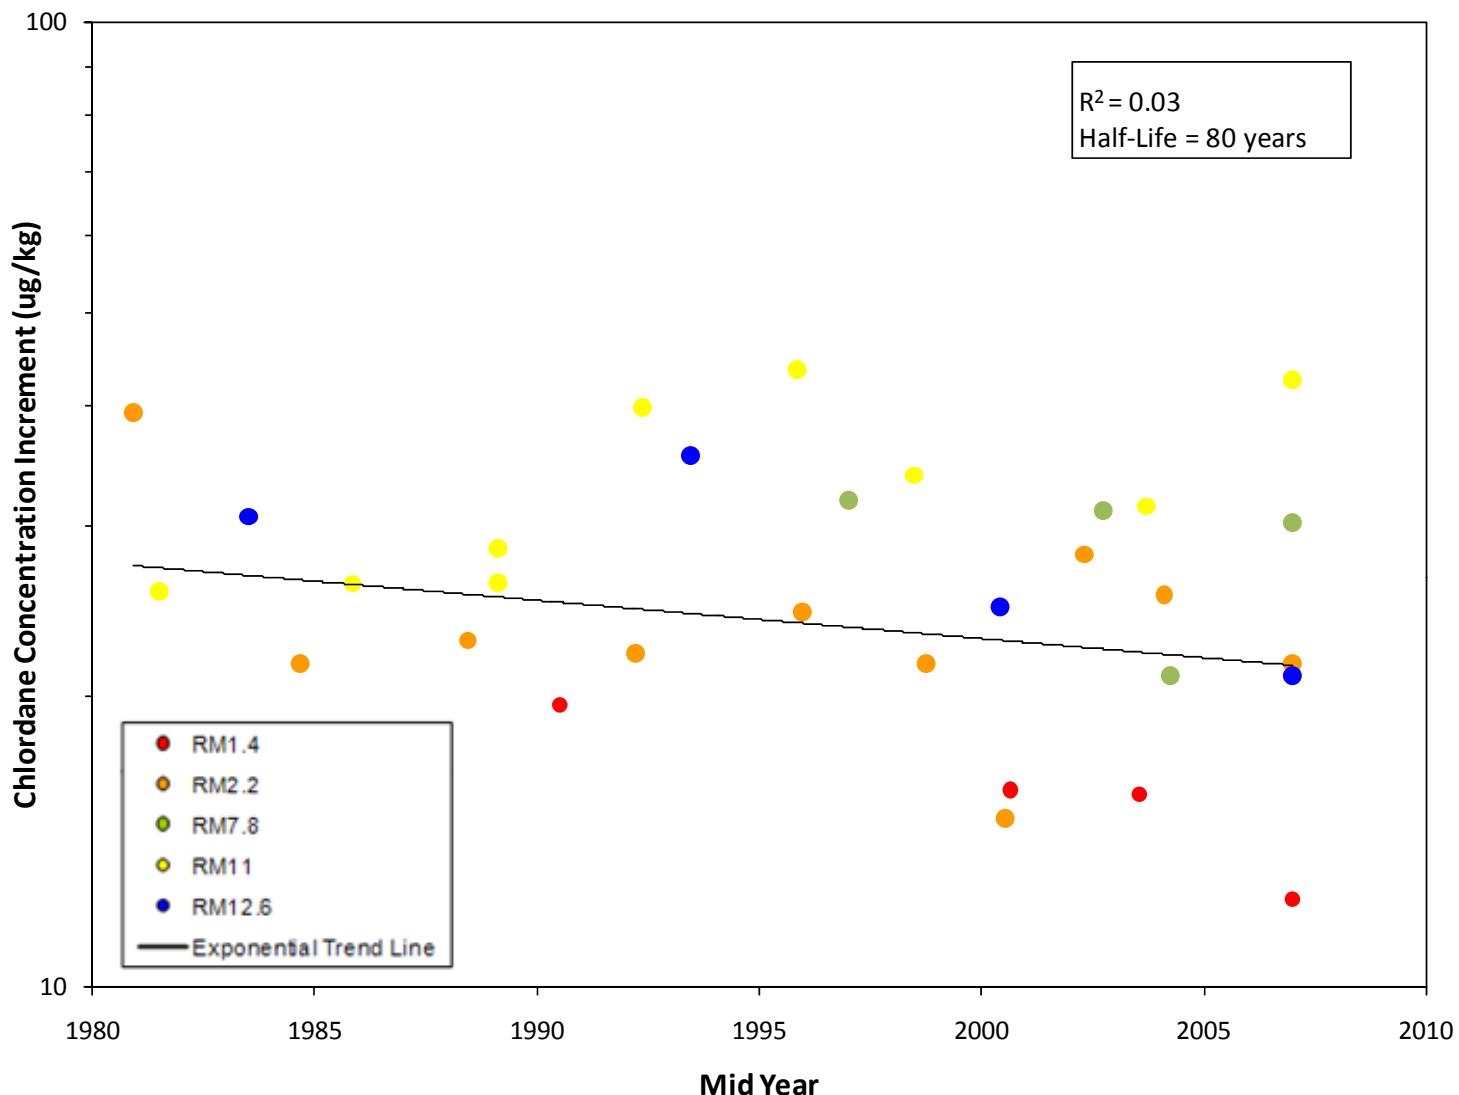
Figure 20-6

Concentration increment represents the difference between the measured concentration in the Lower Passaic River samples and the baseline concentration at Dundee Dam. The increment is attributed to resuspension and Newark Bay derived loads.

Chlordane Concentration Increment due to Resuspension and Newark Bay vs. Mid Year
Lower Passaic River Restoration Project

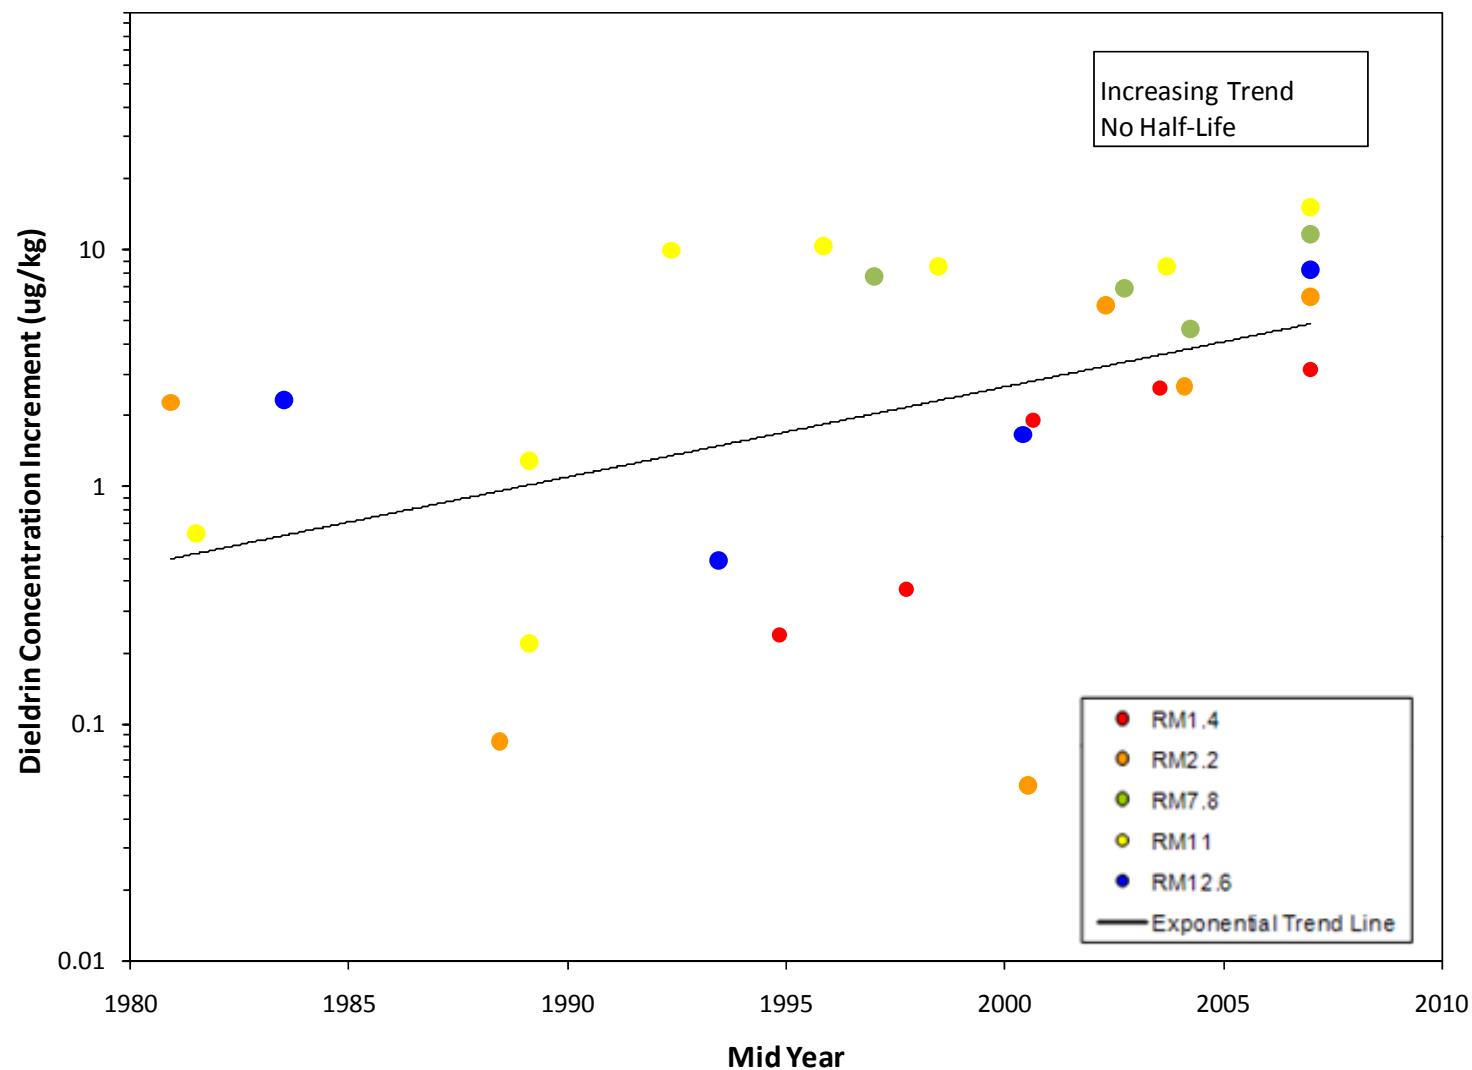
Figure 20-7

Concentration increment represents the difference between the measured concentration in the Lower Passaic River samples and the baseline concentration at Dundee Dam. The increment is attributed to resuspension and Newark Bay derived loads.

Dieldrin Concentration Increment due to Resuspension and Newark Bay vs. Mid Year

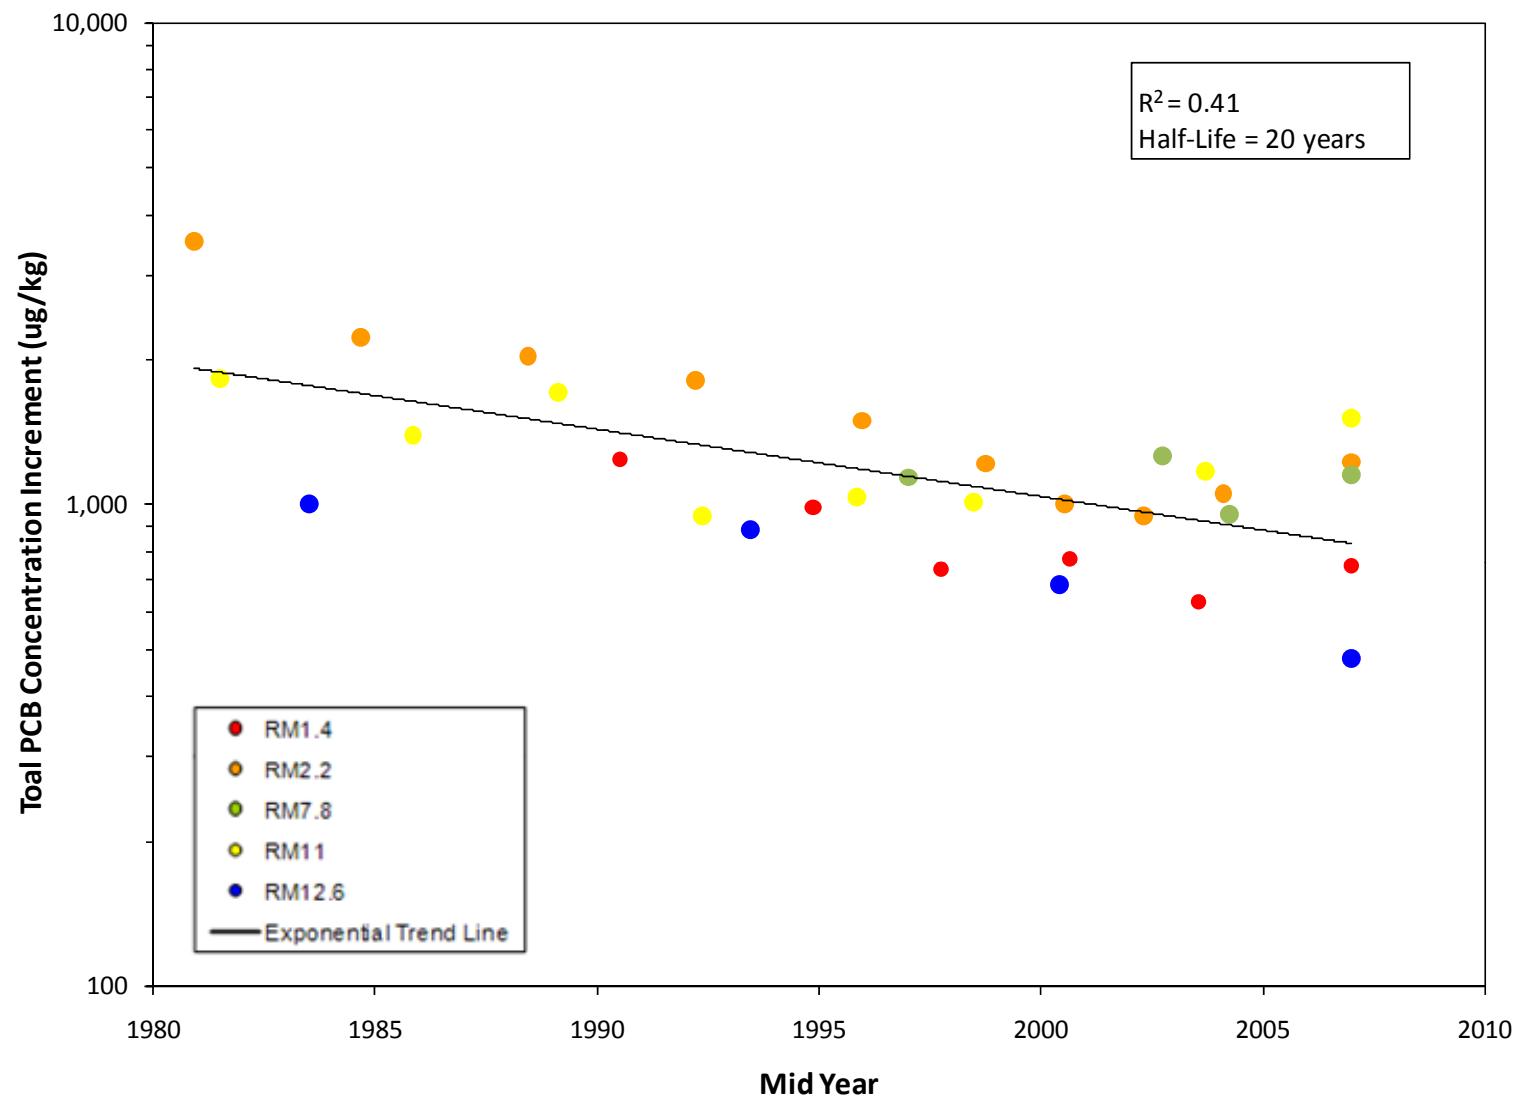
Figure 20-8

Concentration increment represents the difference between the measured concentration in the Lower Passaic River samples and the baseline concentration at Dundee Dam. The increment is attributed to resuspension and Newark Bay derived loads.

Total PCBs Concentration Increment due to Resuspension and Newark Bay vs. Mid Year

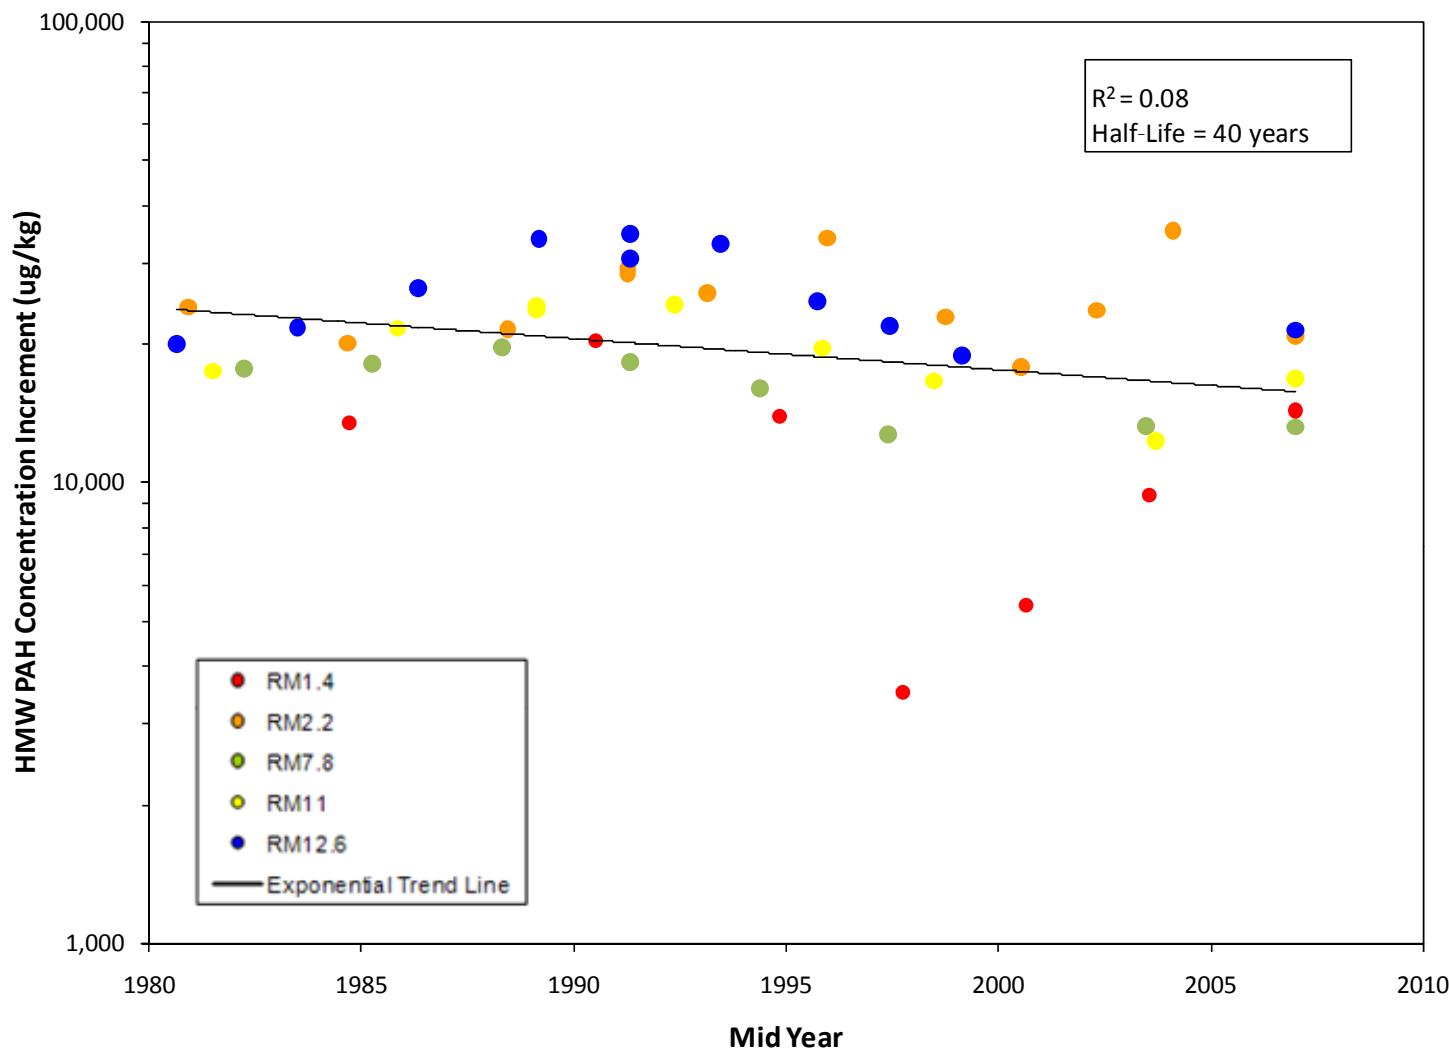
Figure 20-9a

Concentration increment represents the difference between the measured concentration in the Lower Passaic River samples and the baseline concentration at Dundee Dam. The increment is attributed to resuspension and Newark Bay derived loads.

High Molecular Weight PAHs Concentration Increment due to
Resuspension and Newark Bay vs. Mid Year
Lower Passaic River Restoration Project

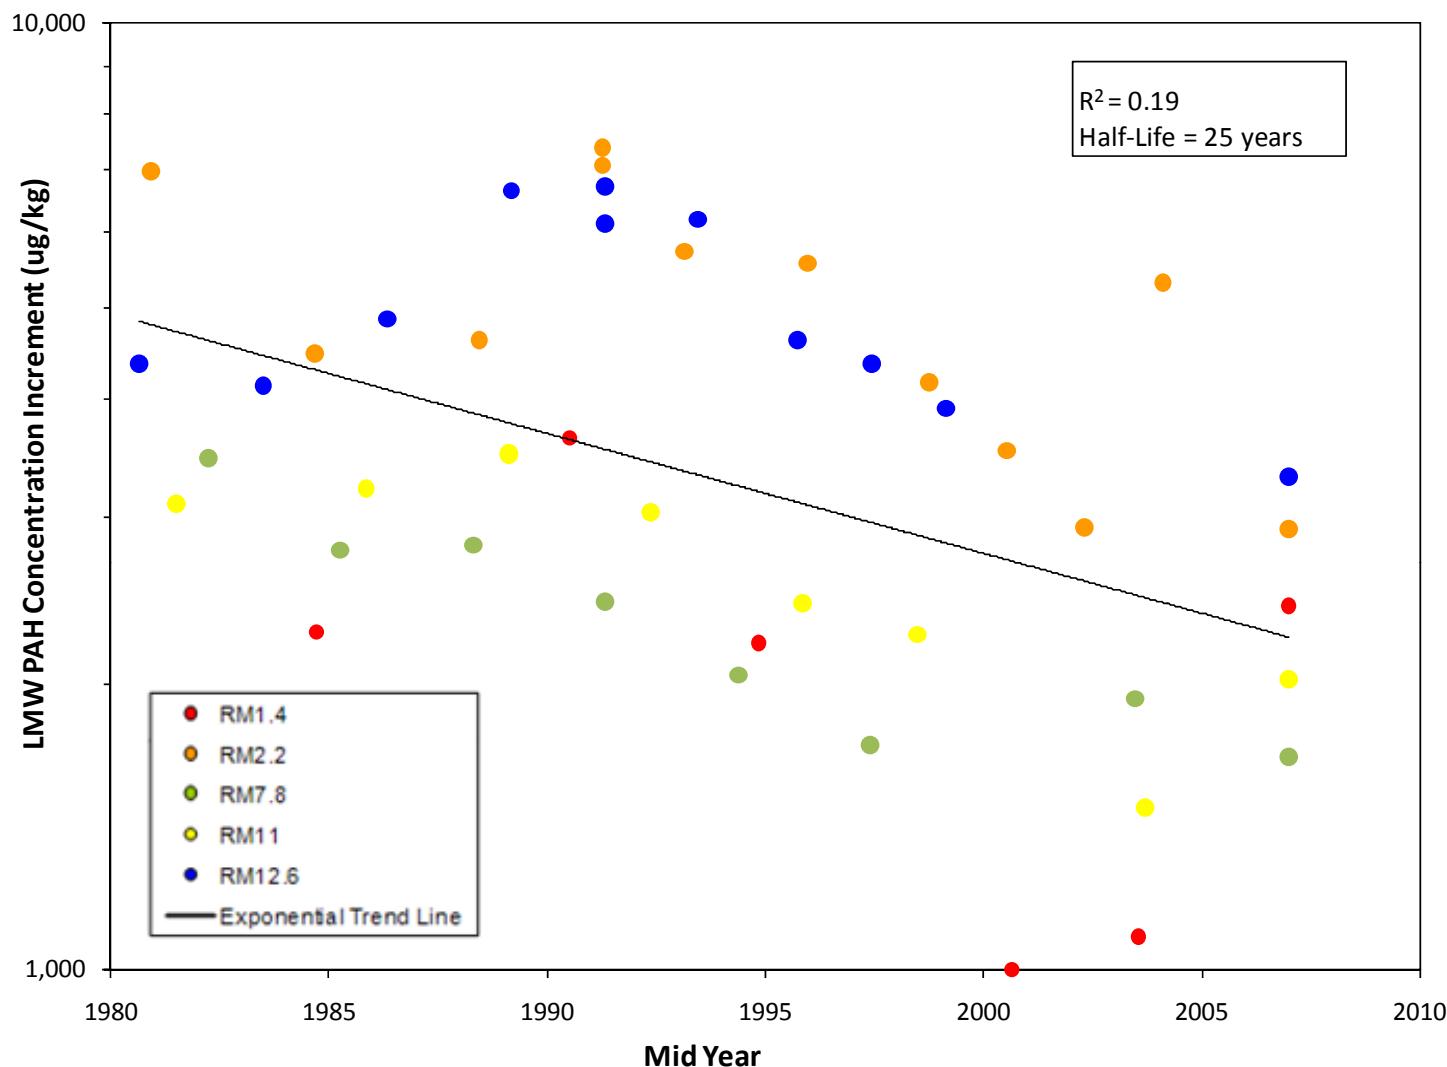
Figure 20-9b

Concentration increment represents the difference between the measured concentration in the Lower Passaic River samples and the baseline concentration at Dundee Dam. The increment is attributed to resuspension and Newark Bay derived loads.

Low Molecular Weight PAHs Concentration Increment due to
Resuspension and Newark Bay vs. Mid Year
Lower Passaic River Restoration Project

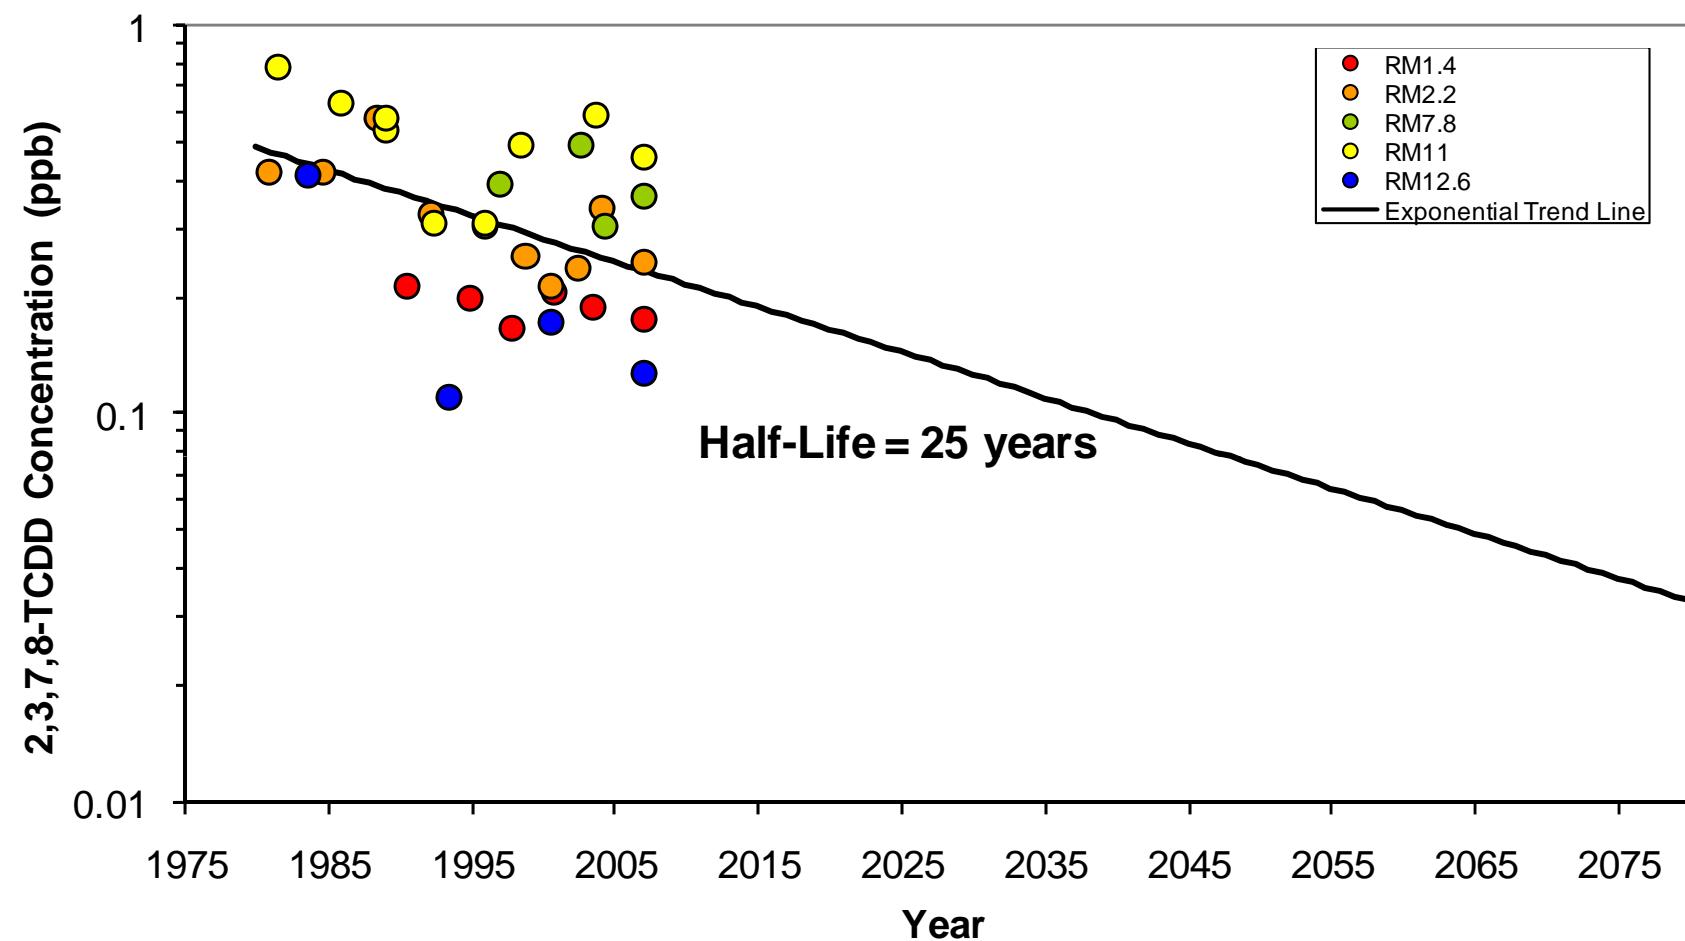
Figure 20-10

High-Resolution Core Results for 2,3,7,8-TCDD

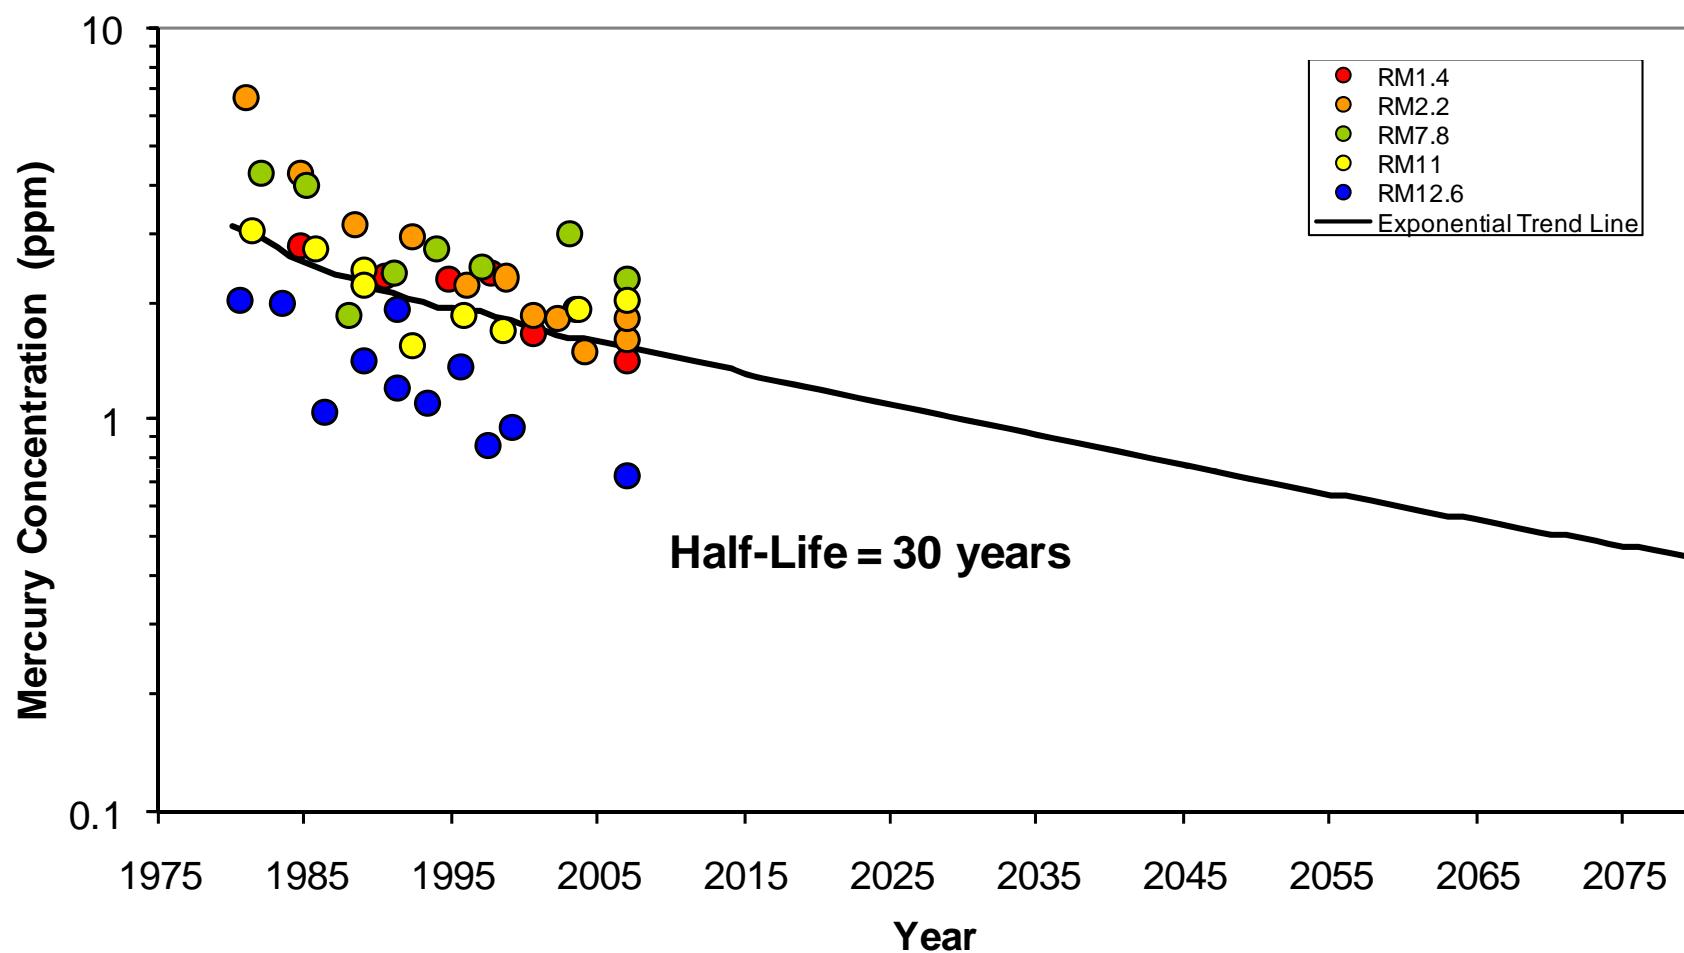
Figure 20-11

High-Resolution Core Results for Mercury

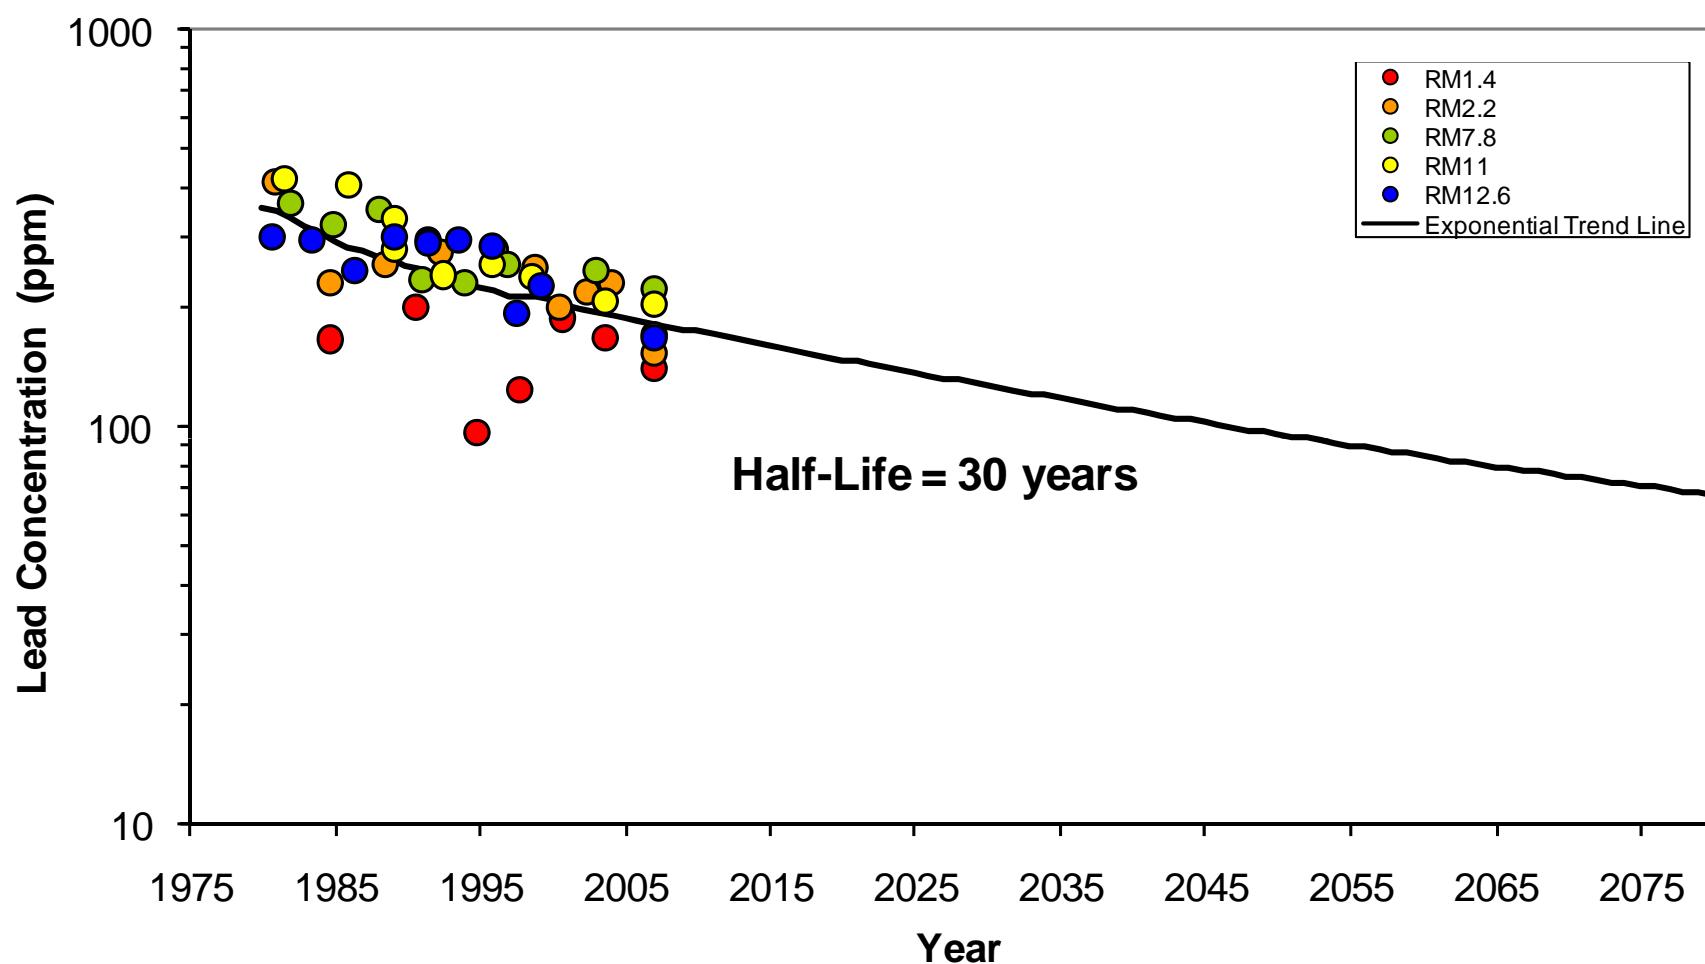
Figure 20-12

High-Resolution Core Results for Lead
